STUDIES OF  
RIGID PVC PIPES  
BY  
SCANNING ELECTRON MICROSCOPY

LENNART JOHANSSON

DISSERTATION 1984

DEPARTMENT  
OF  
CHEMICAL ENGINEERING II  
CHEMICAL CENTRE

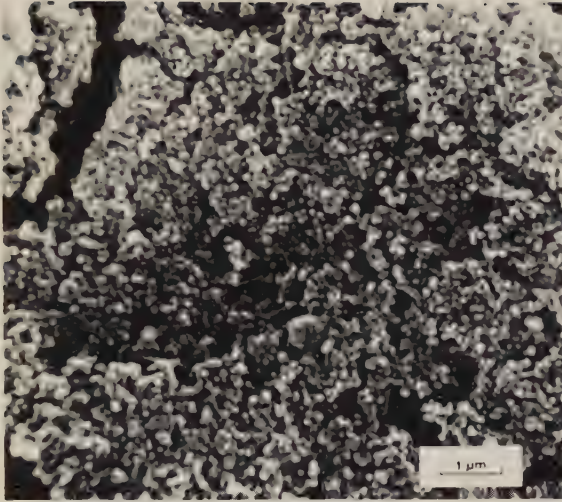
Fracture surfaces obtained in tests at low stresses had a topography quite different from those obtained at high stresses and short times. In the first case, the fractures seemed to have been initiated by particles of different kinds (Table 1). One example of this is shown in Fig. 1 (sample 4). This fracture surface contained a particle which consisted of resin that was not fully plasticized. The large grains consisted of small spherical particles of about  $0,1\ \mu\text{m}$  in diameter. These were probably primary particles of E-PVC [11] present as an impurity. Cracks of different sizes could be seen within the emulsion particles (Fig. 1). These probably corresponded to the point where the fracture was initiated. This type of fracture, which has previously been called an adhesion fracture [12], was observed in 12 of the 17 samples studied. Another example is shown in Fig. 2 (sample 14). In this case the fracture surface contained a particle with a diameter of about  $0,1\ \text{mm}$ . As can be seen, a radial crackgrowth has occurred across the mirror area. At a high magnification (Fig. 3) the mirror area was found to be covered by fine threads. This indicated that the fracture was accompanied by plastic deformation. As also seen in Fig. 3, knots were present at the tips of the threads. These were probably formed by relaxation processes [13]. A comparison of different fracture surfaces showed that increasing time-to-failure tended to give finer threads and smaller knots, possibly due to a lower rate of crack propagation. The pattern of the fracture surface changed considerably beyond the mirror area (Fig. 2). Here, a similar rough structure could be seen as in fracture surfaces from impact tests [14], indicating a sudden increase in the rate of crack propagation. Similar transitions from a mirror surface to a rough fracture surface have previously been observed in PVC and in other polymeric materials [15, 16].

Figure 1. Cracks within an E-PVC particle. Primary particles, size about 0,1 μm (sample 4).

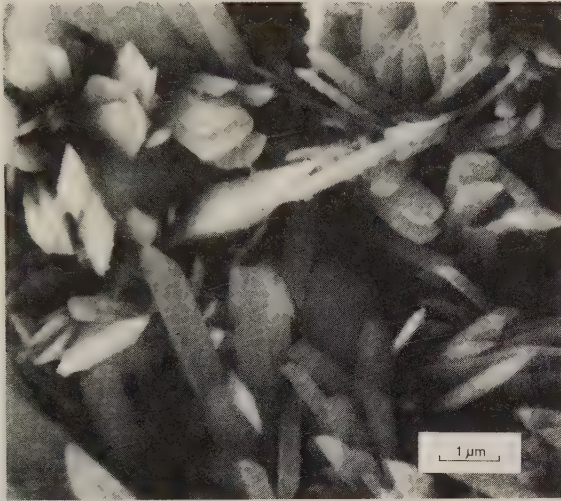
A bluish-green particle was observed in the fracture surface of another sample. Microanalysis indicated the presence of chlorine and copper in the particle. It is possible that the crystals seen in SEM were formed by reaction between a copper-containing impurity and hydrochloric acid evolved during the test period.

Figure 5. A particle consisting of small crystals initiating the fracture in sample 15.

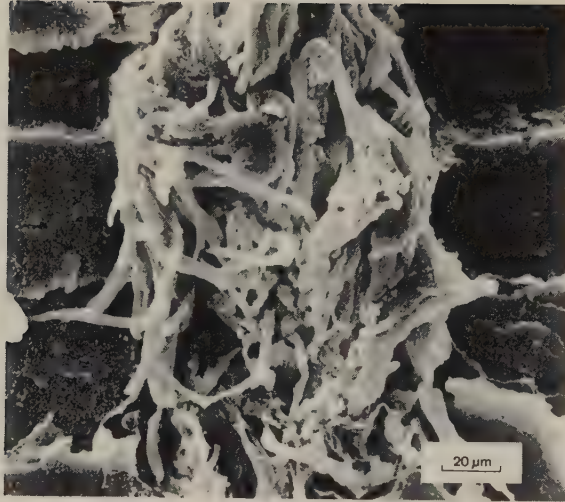
The second group contained foreign particles, i.e. particles with a chemical composition different from that of the components in the formulation. One such particle consisted of twisted threads with a diameter of 3-5  $\mu\text{m}$ . Microanalyses of the threads indicated that they were fillings from the extruder mixed with some additives. As the extruder is worn down during processing it is not surprising to find small particles in the extruded pipes.

Figure 7. A particle consisting of twisted threads in the fracture surface of sample 11.

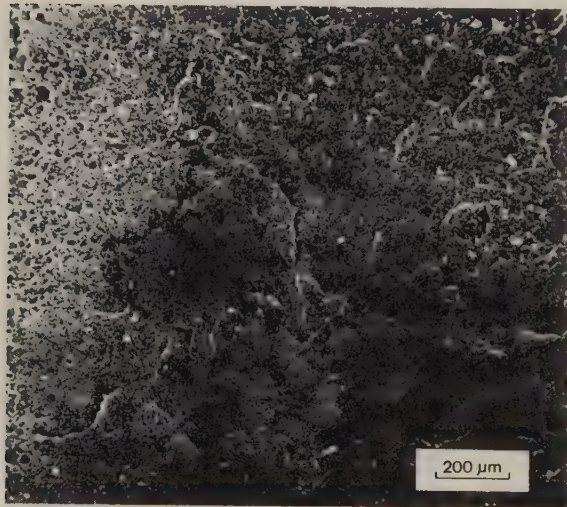
Figure 8. Topography image of the point of initiating of the fracture in sample 18.

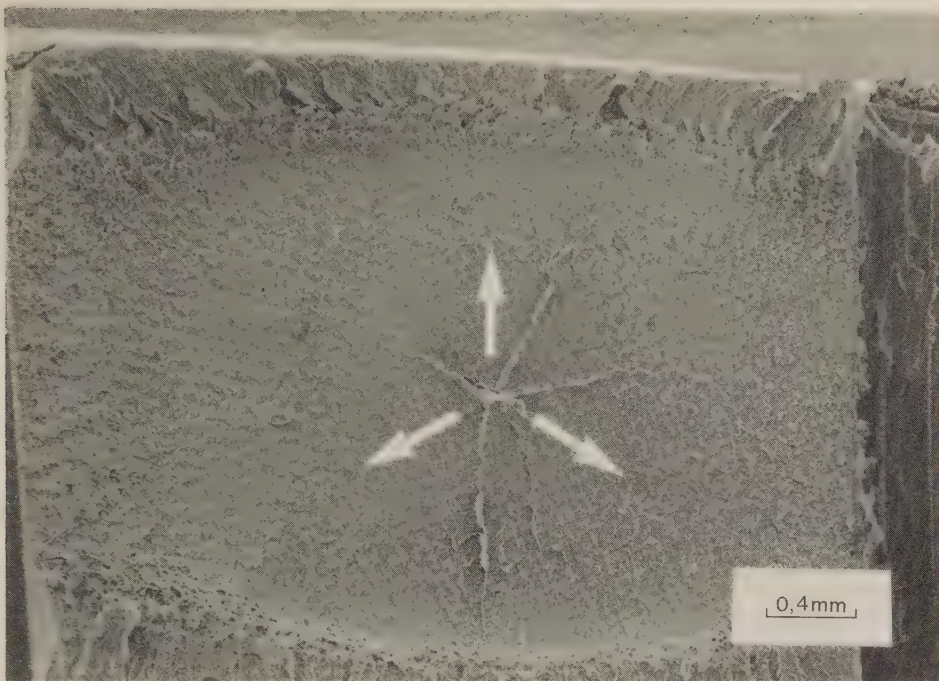
Figure 11 a. An inclusion in the central part of a PVC pipe's fracture surface. The direction of fracture propagation is shown by the arrows.

Fig. 11 a exemplifies a fracture surface of this type. The light microscope showed these inclusions to be red and yellow and most of them had a particle size between 50 and 100  $\mu\text{m}$ . They were found in the pigmented pipes and, according to energy dispersive X-ray analysis, contained chromium and lead as the only detectable foreign elements (Fig. 12). This indicated that they consisted of agglomerates of the red and yellow components of the pigment used. The pigment agglomerates were cracked, which must have happened during testing and not during preparation for microscopy. One proof of this was the fact that the fractured surfaces of the pigment agglomerates were contaminated by depositions from the pressure water of the pipe testing system. More evidence was obtained by analysis of an X-ray exposure of a tested pipe which contained more than one hundred growing cracks. The X-ray film showed that the particles in the cracks were fractured. All the growing cracks in this pipe were studied

by light microscopy and about 10 by electron microscopy. It was found that, in general, fragments of pigment particles were attached to both of the fractured surfaces. This study also showed that the largest pigment agglomerates were present in the two cracks which had penetrated the pipe wall and caused the actual failure.

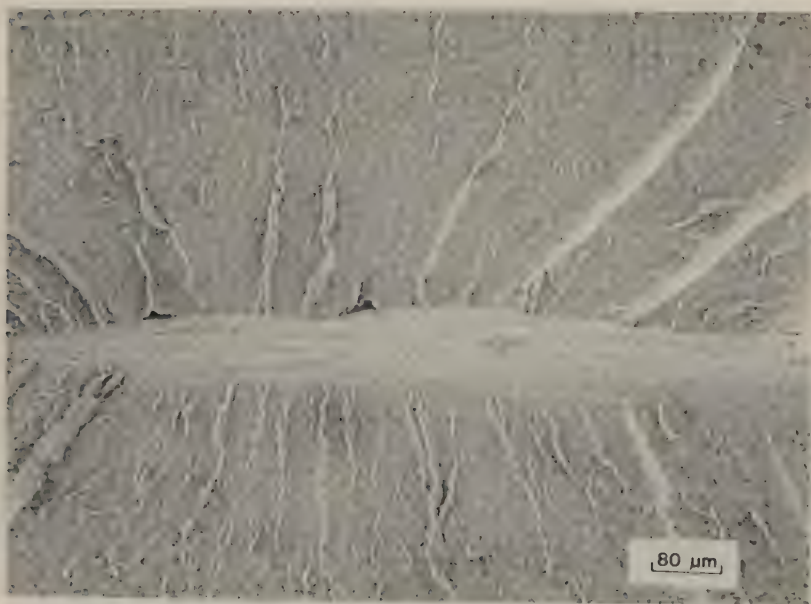
Figure 7. The fracture surface obtained at the longest time-to-failure contained no particles but a large line defect.

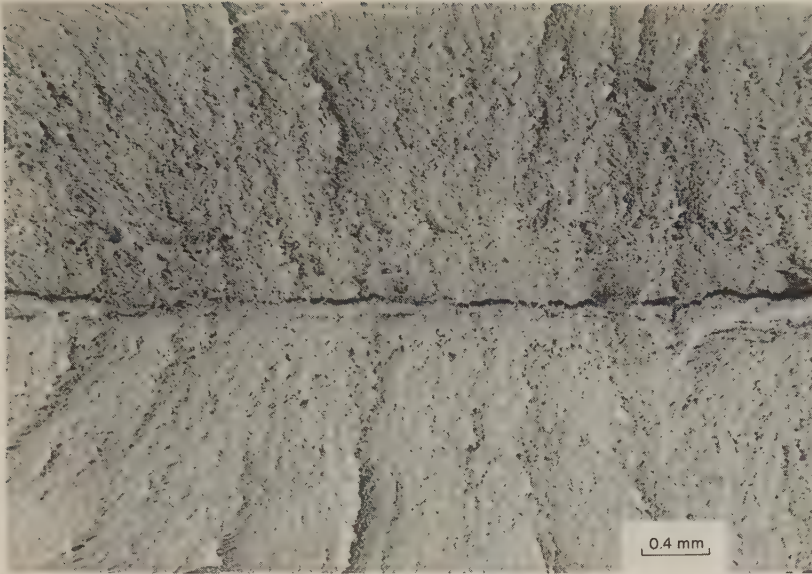
Figure 1. Fracture initiation along a line running down the middle of a rigid PVC pipe.

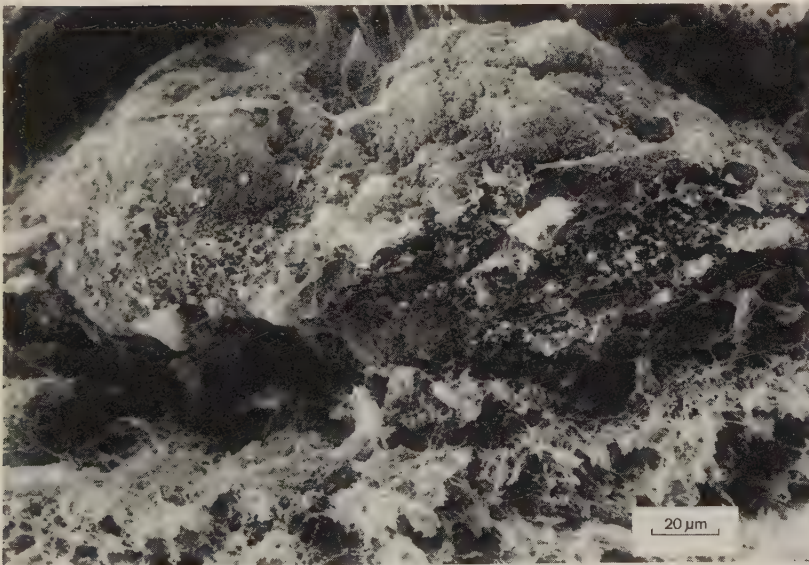
Figure 2. Two S-PVC resin particles at the line of fracture initiation.
